## Faulty 9-Track Cipher F880 Tape Drive

#### It's time to fix my 9-track tape drive, a Cipher 880.

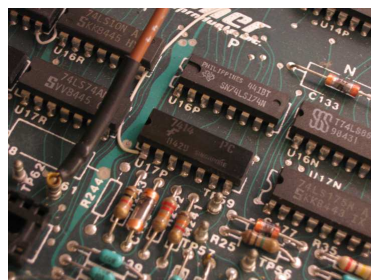
Running the tape drive open, another problem suddenly appeared - the vacuum motor was constantly "on". Running diagnostic test No. 34 and pressing the LOAD button did not manage to switch it off either. I have tracked the problem to a faulty chip, U17P (A 7438 hex schmitt trigger inverter).

The offending IC should only have pins 5 and 6 used, but its pin 1 is connected via a long jumper wire to one of the Z8036 IC's, meaning the schematics are not complete, perhaps this patch was part of what made this drive a F880 ? I can't tell whether the original PCB was swapped and I am looking at a replacement from a 891, which was done long, long ago.

After replacing the offending 7414, the problem was solved - the suction motor is again under control. Now it is time to dig in and solve that "error code 17".

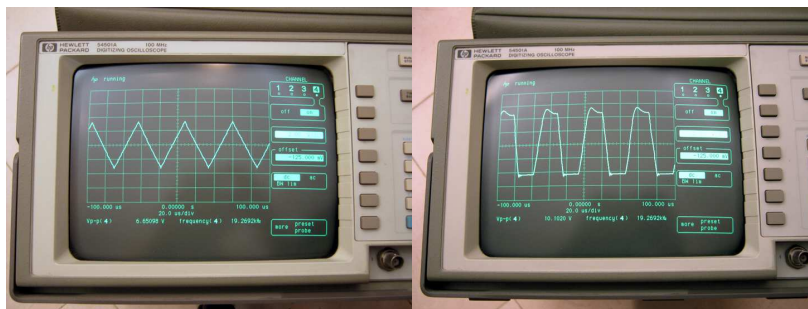
**Test Point Waveforms, Compliance Arm Adjustment**

TP56 looks OK, TP59 looks a bit odd - perhaps U20N (4136 op amp) is faulty ?

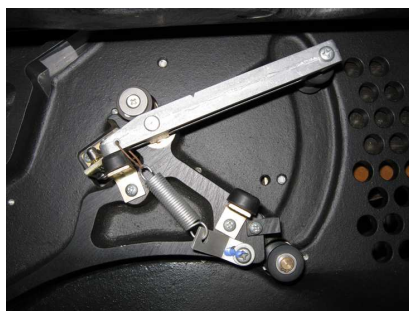
Before attempting a replacement - I tried re-adjusting the compliance arm tension spring, releasing the mounting screw and changing the spring load force (the mounting screw and bracket are the ones marked with blue dye in the photo). But it did not help - code 17 problem persisted, even with spring tension increased or decreased.

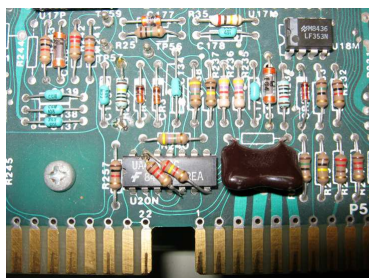
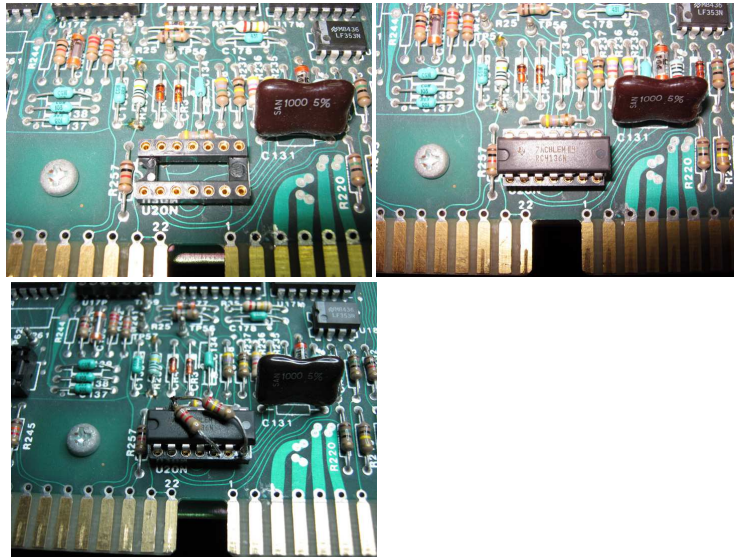
**U20N Replacement**

Testing the tape drive reveals that indeed the 4136 was faulty. Now the tape spins again, and the [video](#) shows the proof !

It is time to replace U20N. I chopped it away, removed the pins, placed a socket instead, and mounted a new 4136. Finished off with re-doing the two resistor patch.
