## Faulty 9-Track Cipher F880 Tape Drive

#### It's time to fix my 9-track tape drive, a Cipher 880.

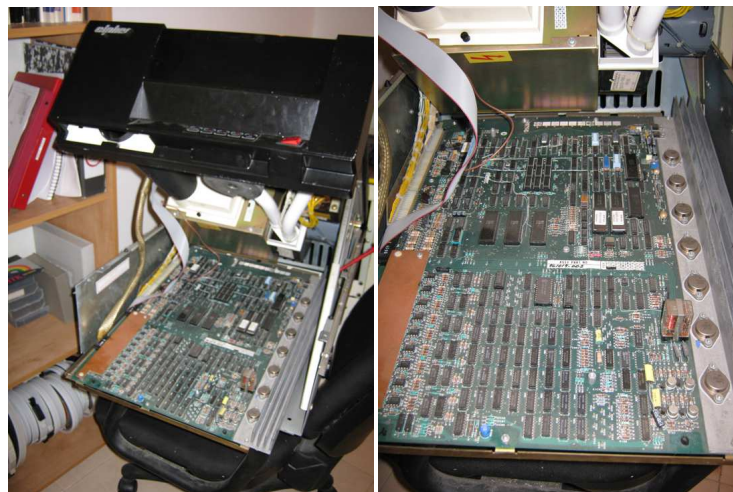
The Cipher 880 9-track tape drive installed on the DSVAX III would usually work up to the point of an "init", but a fault would always develop. The fault is indicated by error code 17 - "LOAD" and "HI DEN" flashing, which means "The compliance arm exceeded its travel limits during normal operation".

Subsequently, testing the arm movement found no problem (service aid 24 found normal voltages).

Checking the huge PCB, I found the components on it do not correspond to the schematics found on the "F880's Operation Maintenance" manual from bitsavers.org . It was rather very similar to the M891 manual . At least IC and resistor designations appeared correct.

Thus I decided to open up the drive and check what gives.
